**EMERGENCY STRUCTURAL ASSESSMENT
OF
EARTHQUAKE DAMAGE TO KAILUA - KONA WHARF
LOCATED AT
KAILUA - KONA, HAWAII

PREPARED FOR
THE STATE OF HAWAII
DEPARTMENT OF LAND AND NATURAL RESOURCES
DIVISION OF BOATING AND OCEAN RECREATION
HONOLULU, HAWAII 96813**

**ARNOLD T. OKUBO & ASSOCIATES, INC.
94-529 UKEE STREET, SUITE 107
WAIPAHU, HAWAII 96797**

NOVEMBER 2006

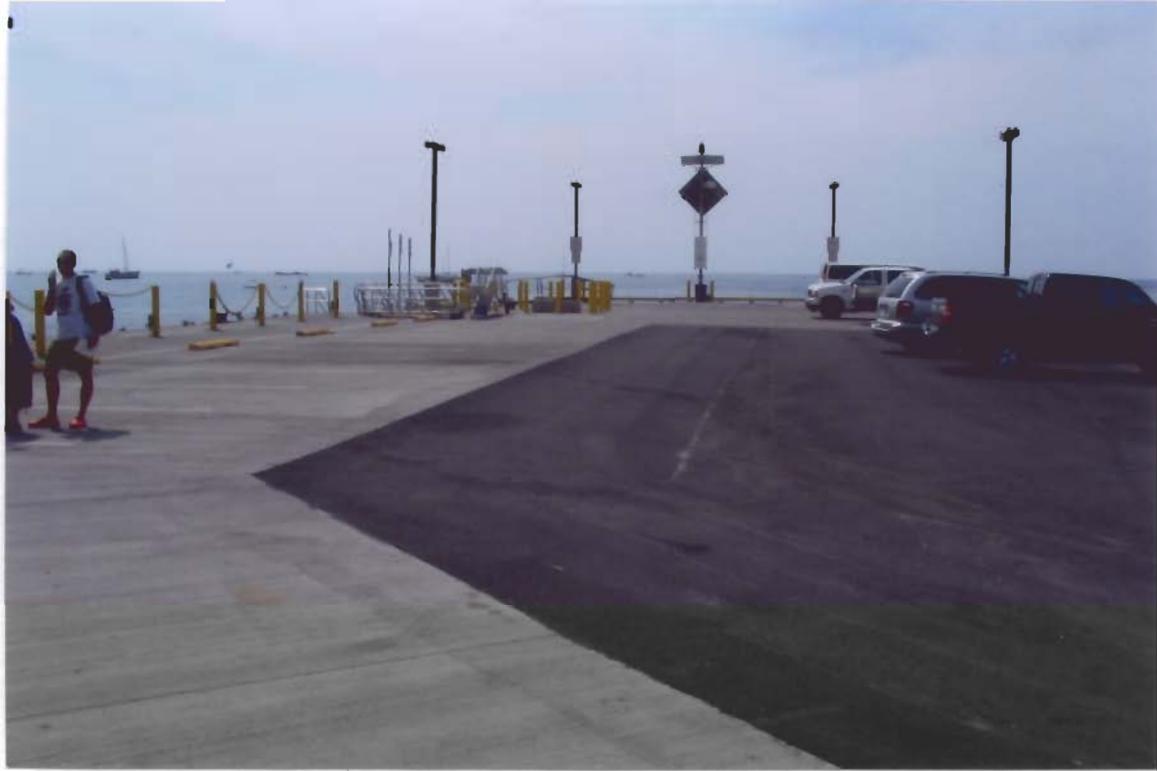
1

Kailua-Kona Wharf -
South End (Looking South)

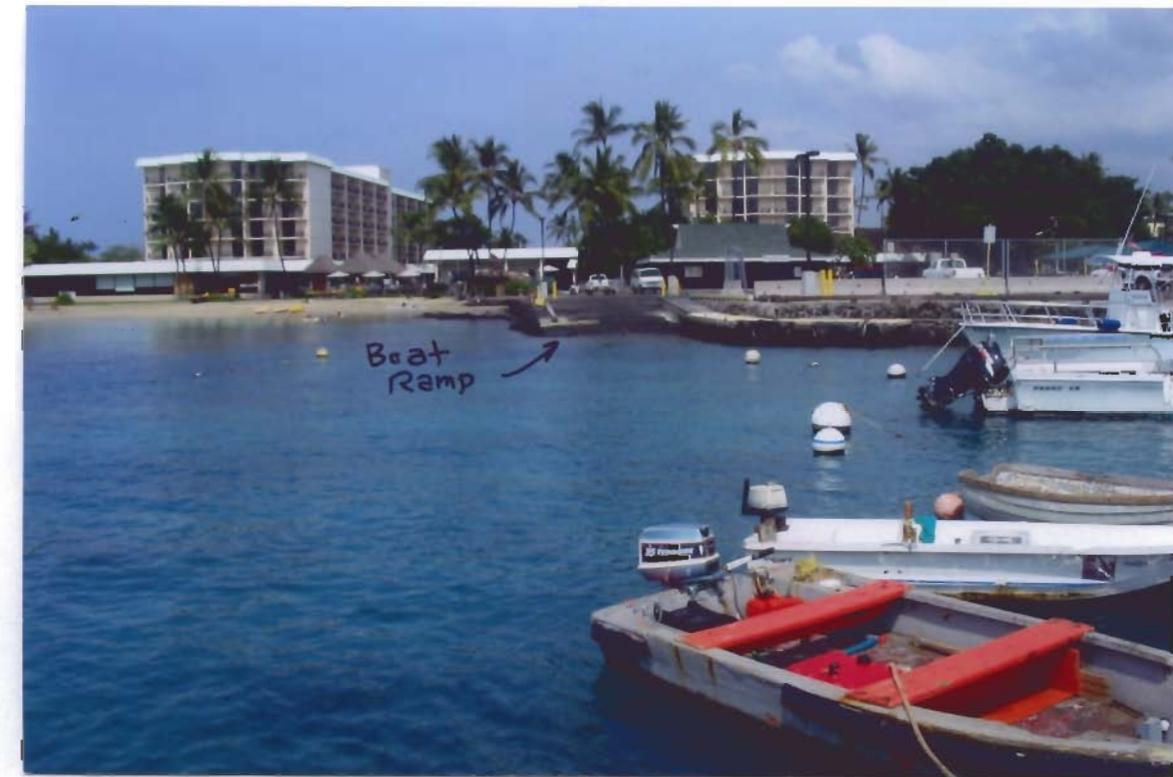
2

Kailua-Kona Wharf Boat Launching Ramp -
North West Side (Looking North)

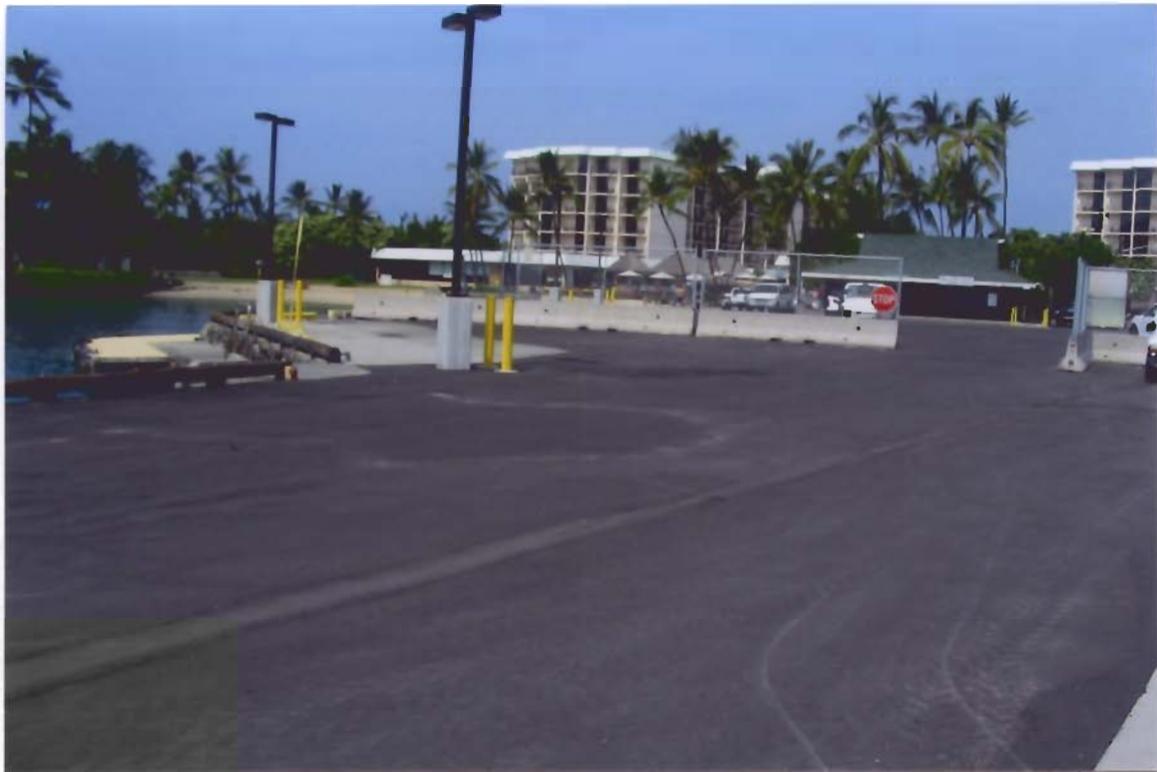
3

Kailua-Kona Wharf
Wharf Parking Area (Looking North)

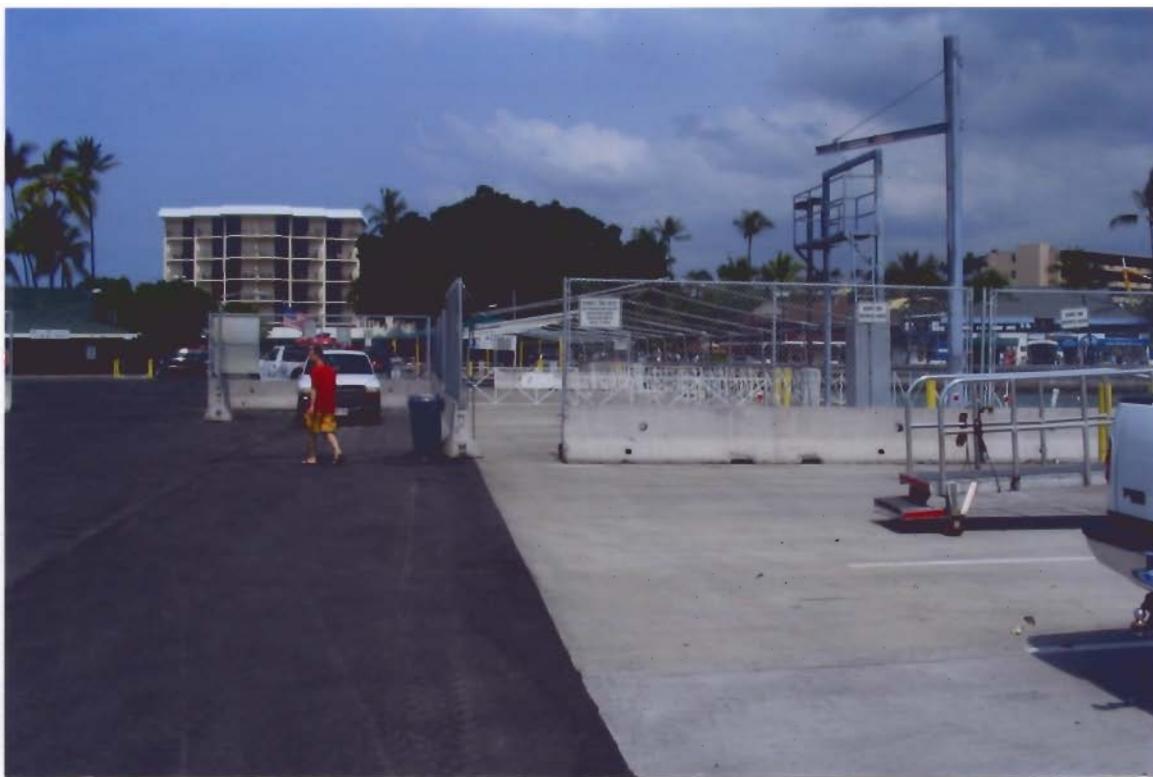
4

Kailua-Kona Wharf
Wharf Parking Area (Looking North)

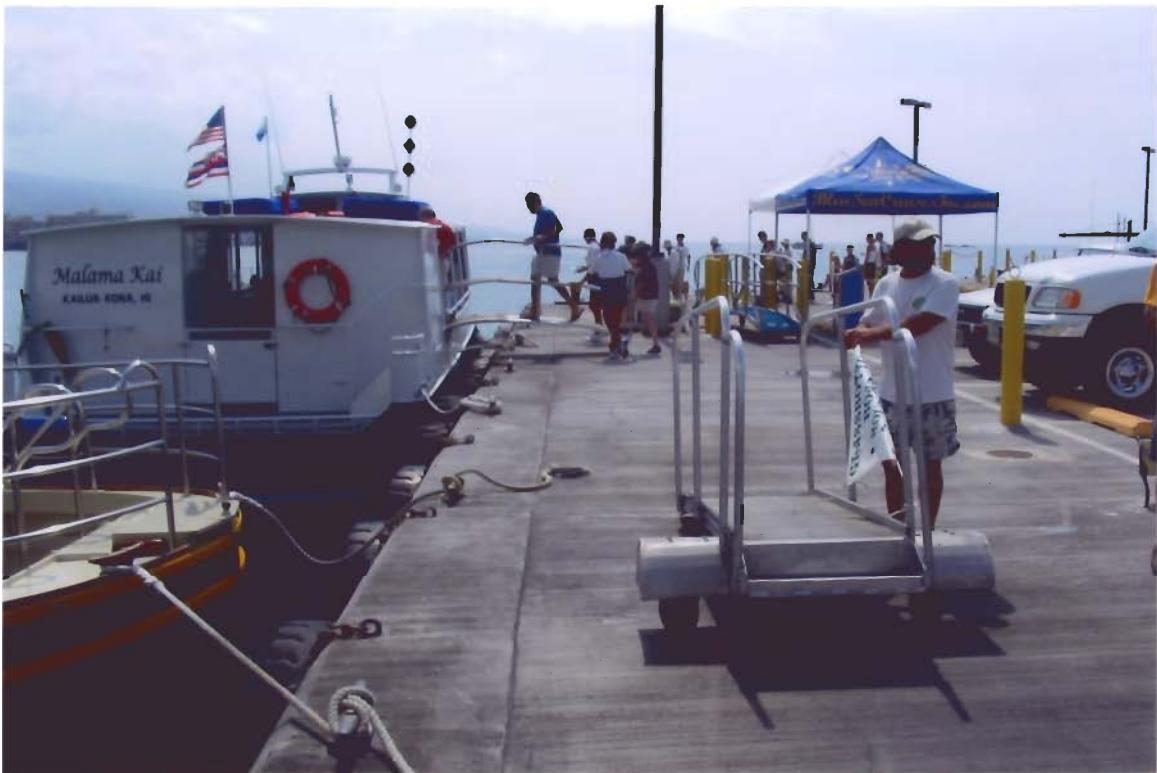
5

Wharf - East Side (Looking South East)

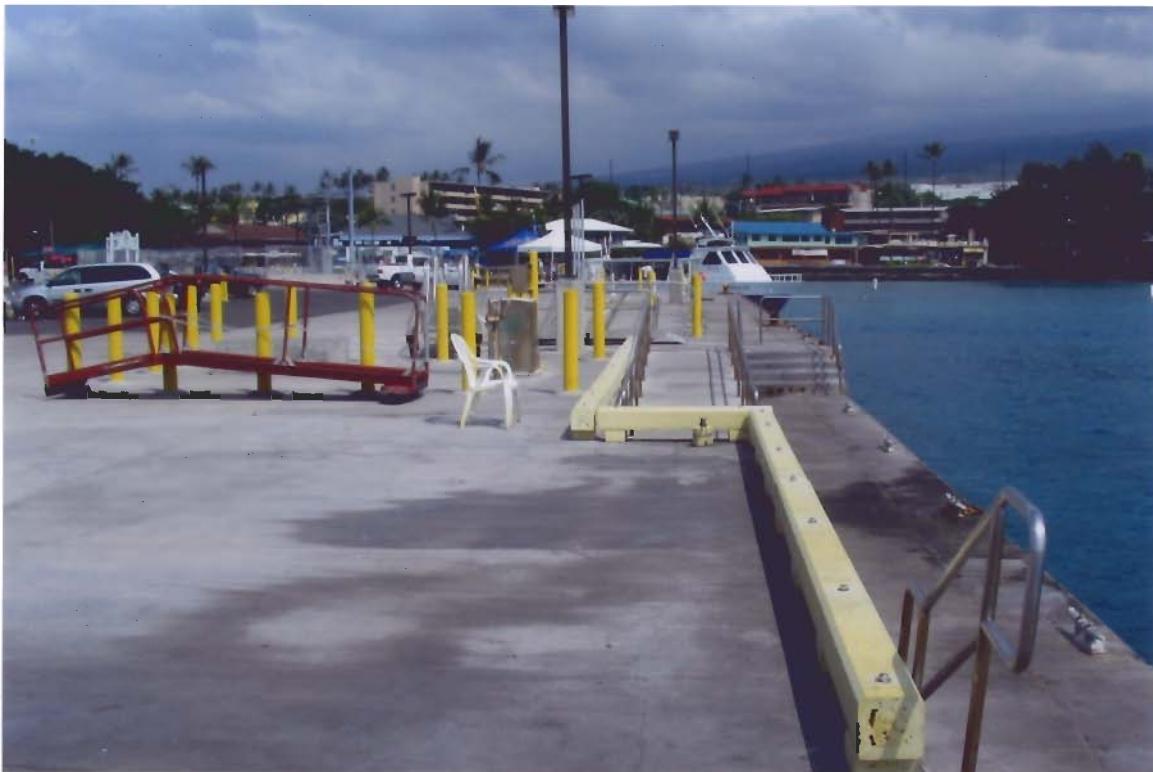
6

Loading Dock No. 2 -
East Side (Looking North)

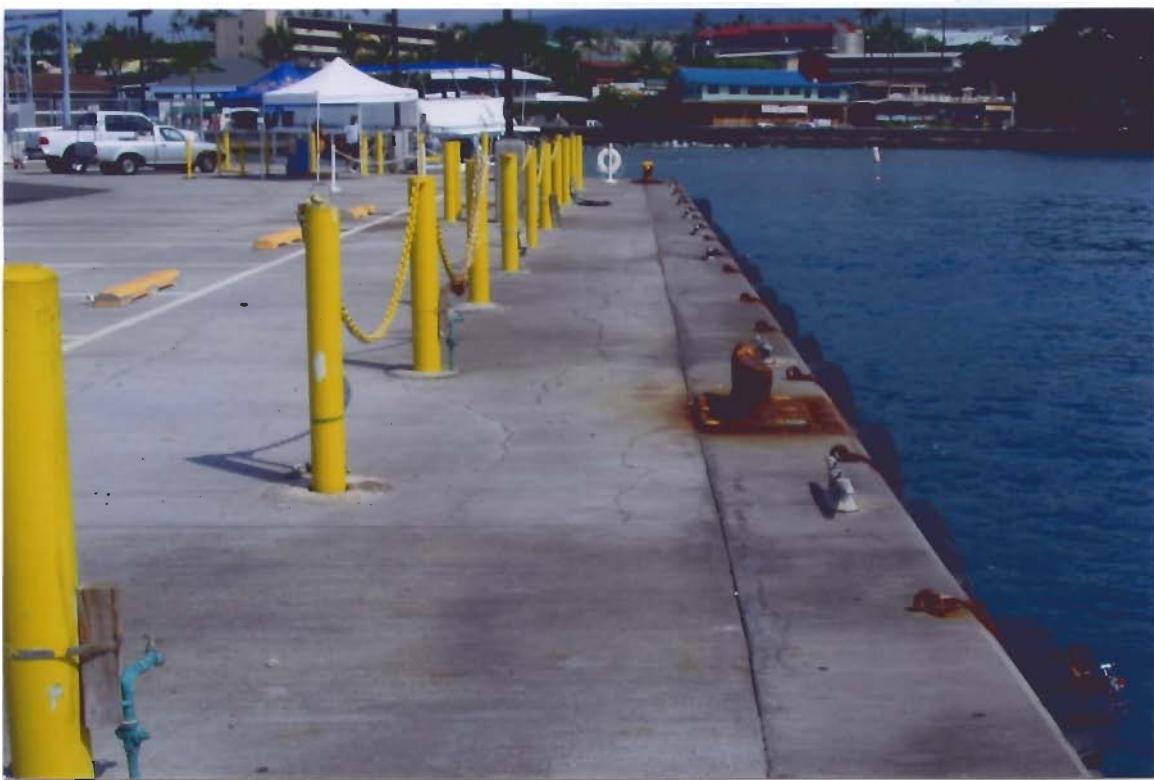
7

Wharf - East Side (Looking North)

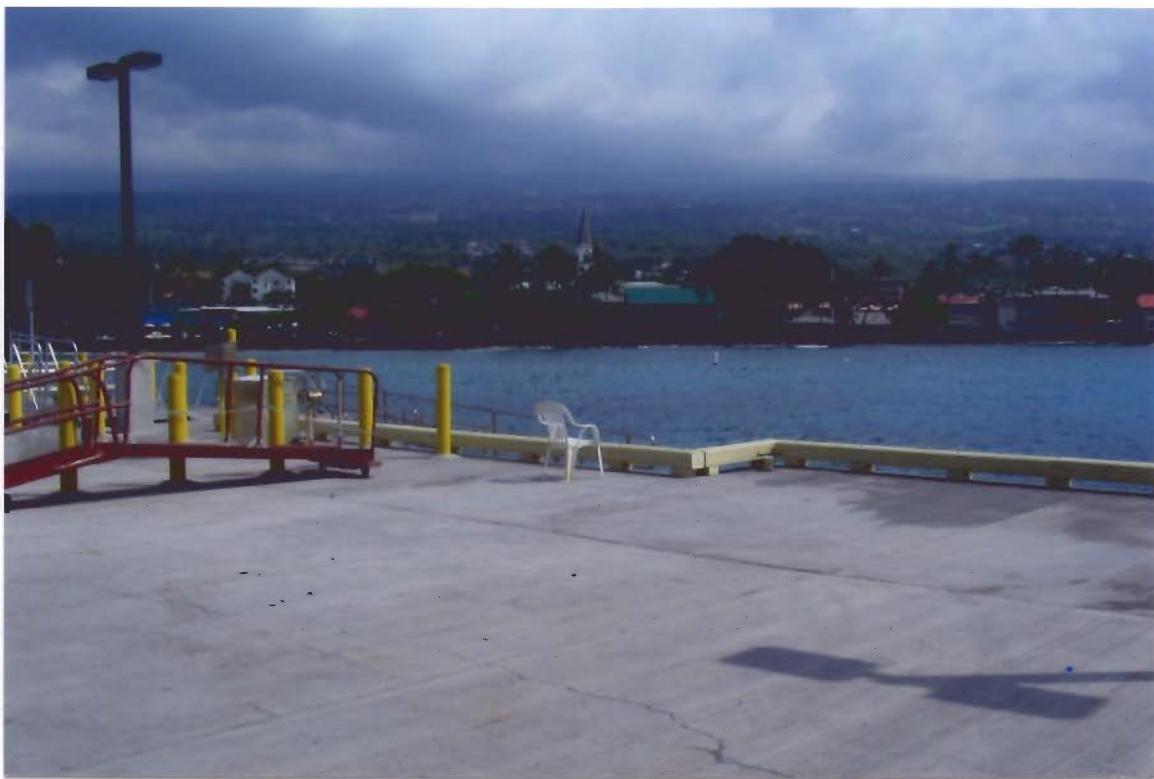
8

Wharf - South East Side at
Loading Dock No. 2 (Looking East)

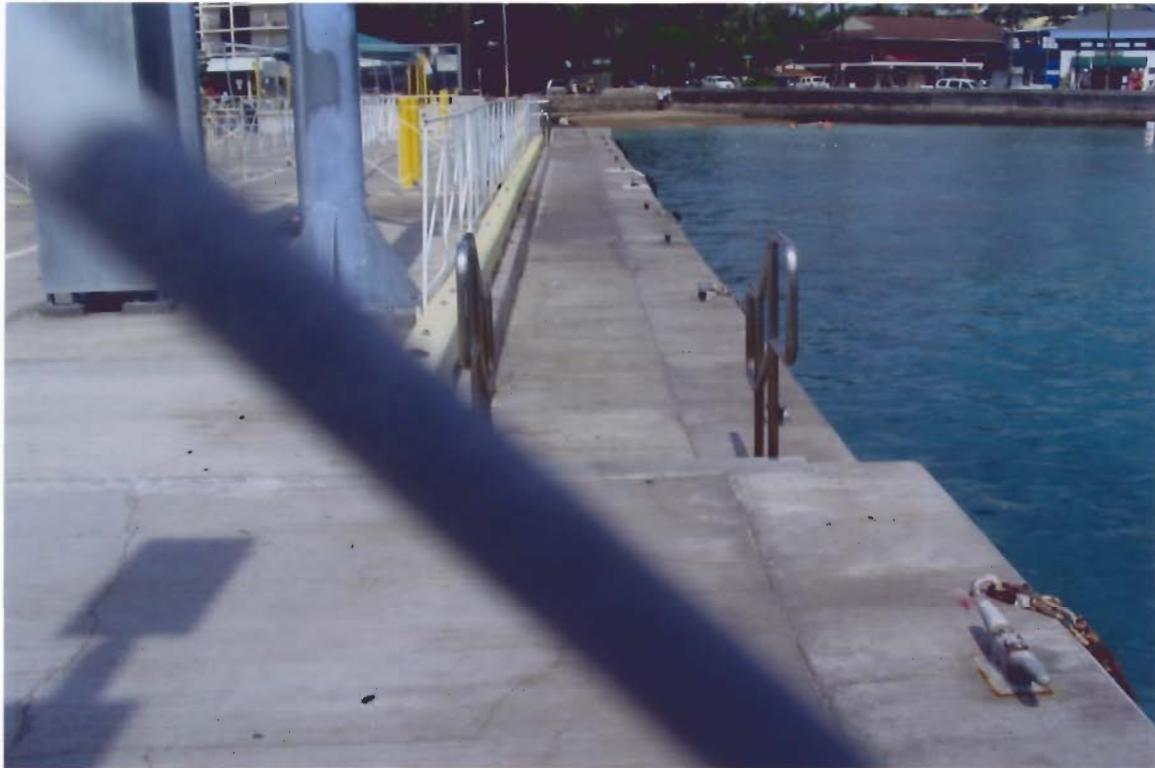
9

Loading Dock No. 1 -
East Side (Looking North)

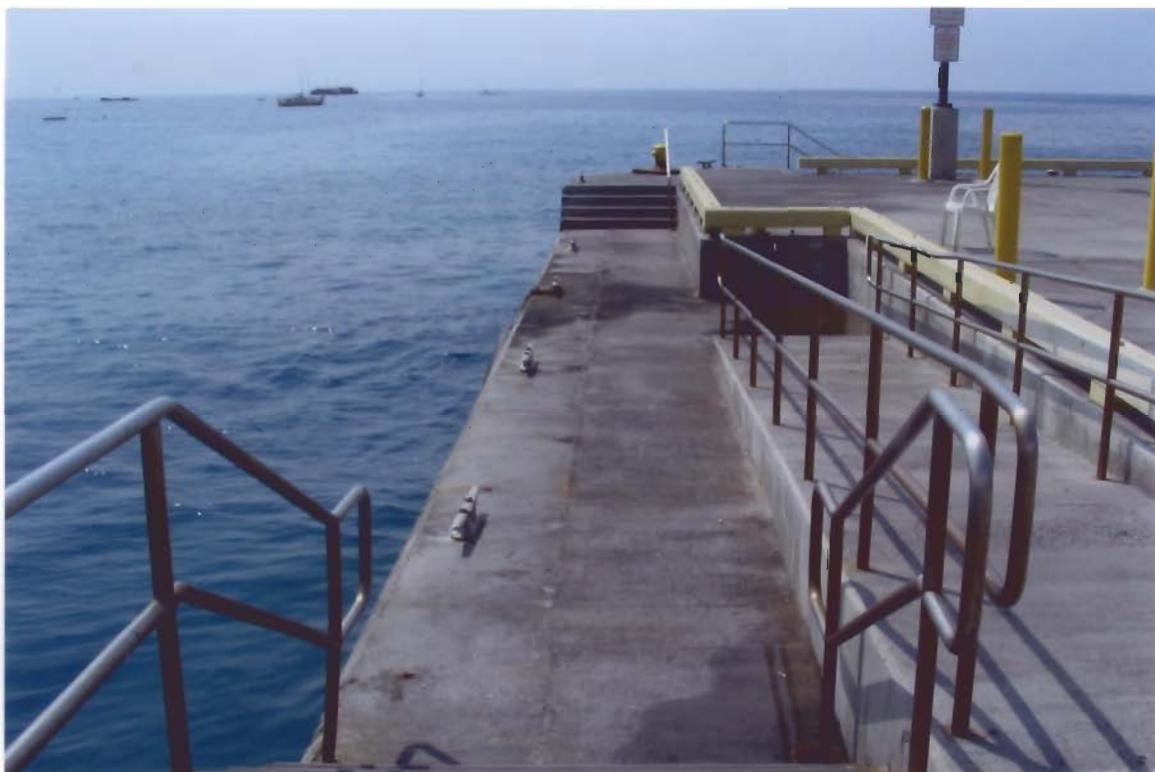
10

Loading Dock No. 2 -
South East Side

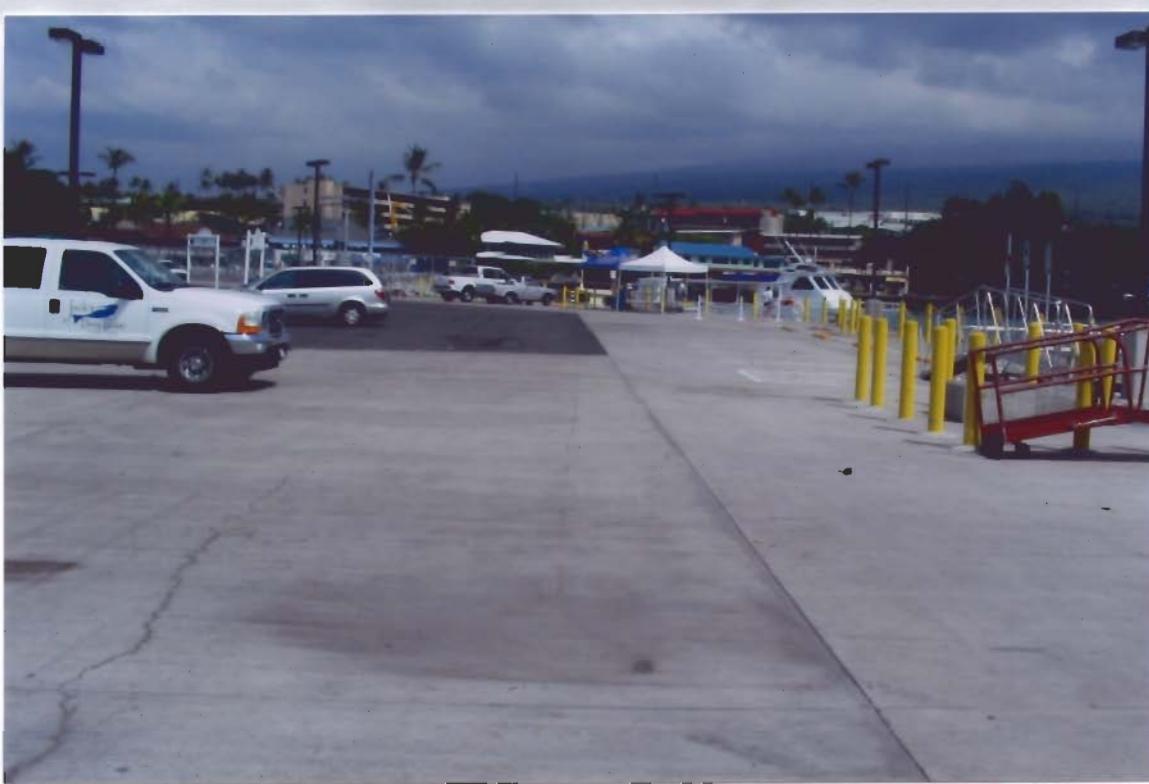
11

Wharf - South End (Looking North)

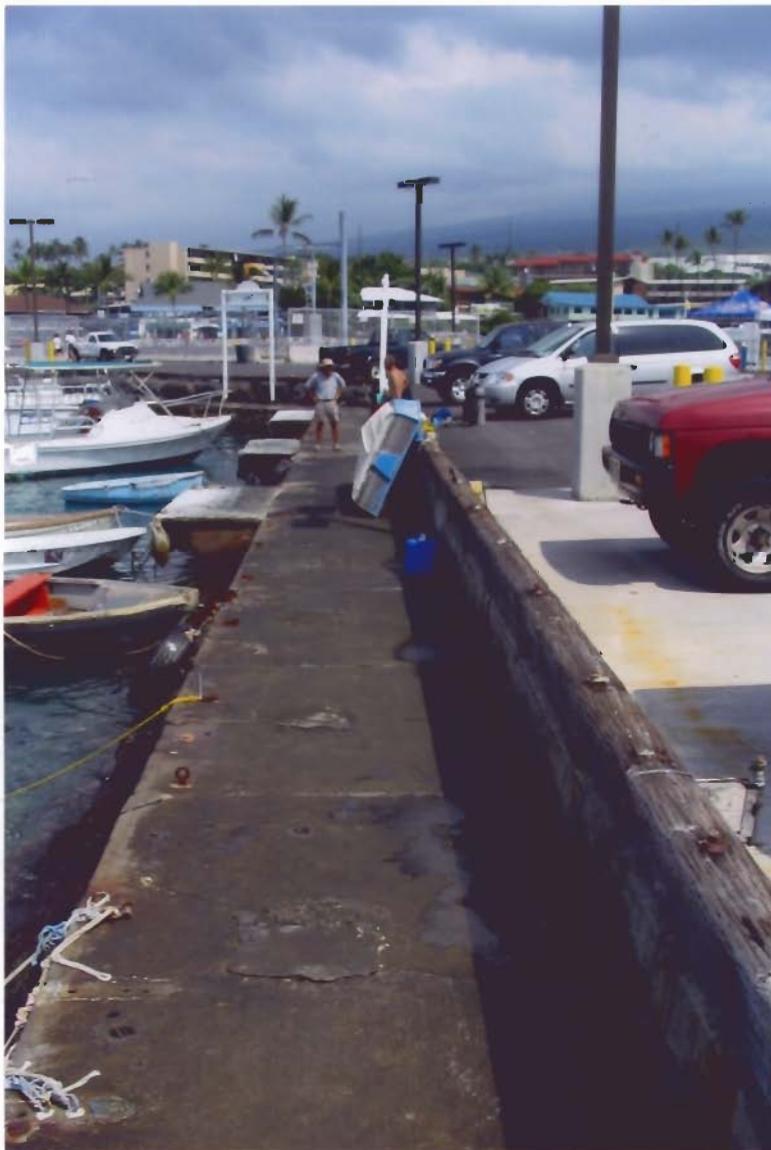
12

West Side Loading Dock
No. 4 (Looking North)

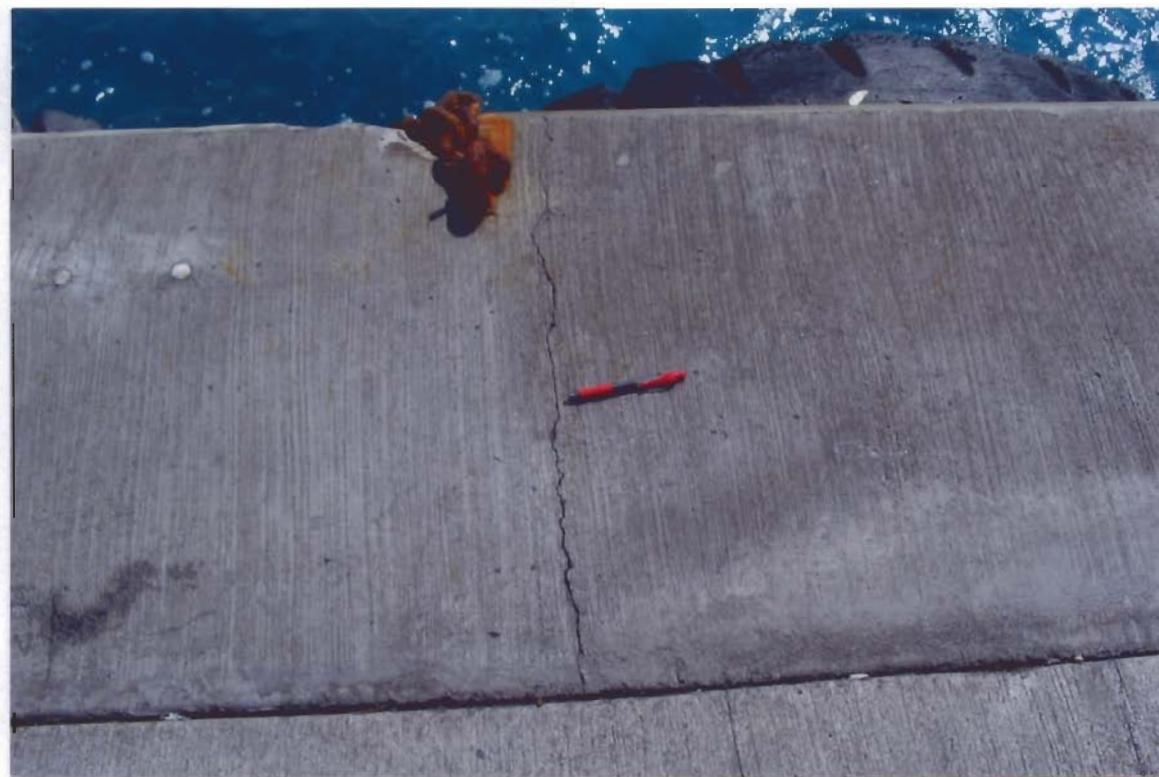
19

- A. Concrete Cap for Steel Sheet Pile Bulkhead - Concrete cap along the length south east side of the wharf have many cracks. Cracks run the full height and through the caps. The cracks are about 5'-0" to 7'-0" apart along the length of the east side bulkhead wall. See photos.

East Side - Typical cracks on deck slab throughout

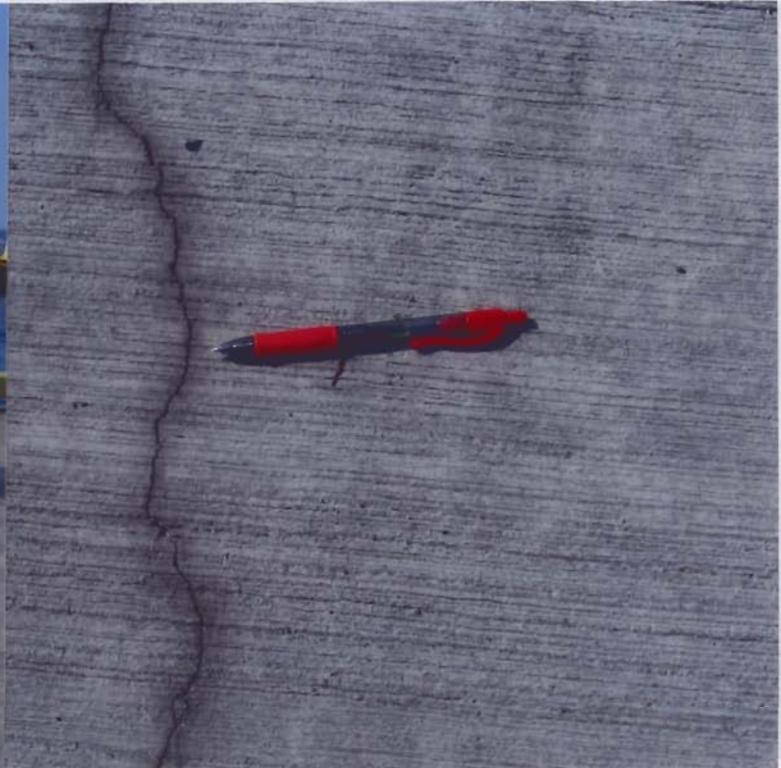
37

Close-up view of cracks
on slab area

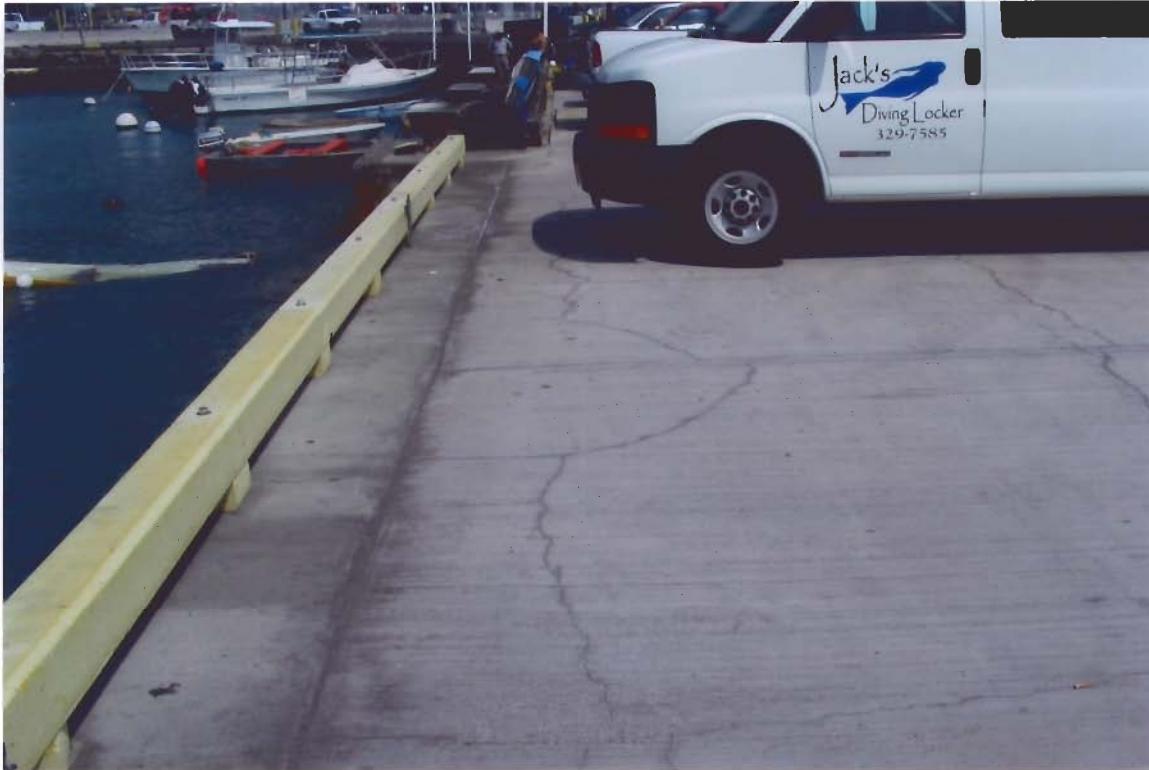
43

- B. Concrete Slab on Grade - There are many cracks throughout the concrete slab on grade. The crack are up to 3/32" wide. Most of the damage slab occurred at the south end of the wharf. See photos.

South West Side - Typical cracks
on slab deck area throughout

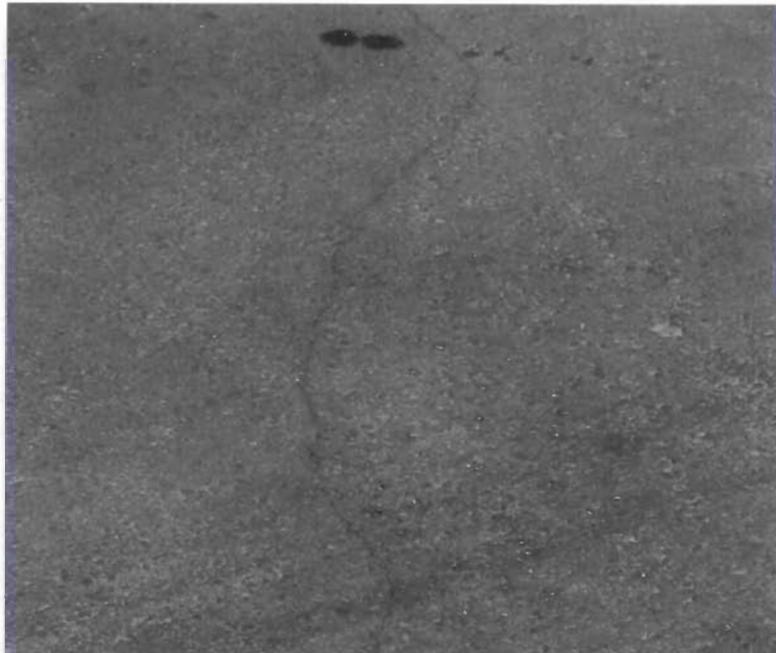
47

- C. A.C. Pavement - There are some cracks on the A.C. pavement at the north end of the wharf parking area. See photos.
- D. CRM Wall - The CRM retaining wall have many cracks along the wall. The CRM wall is located on the west side of the wharf. See photos.

North West Side -
Cracks at A.C. pavement

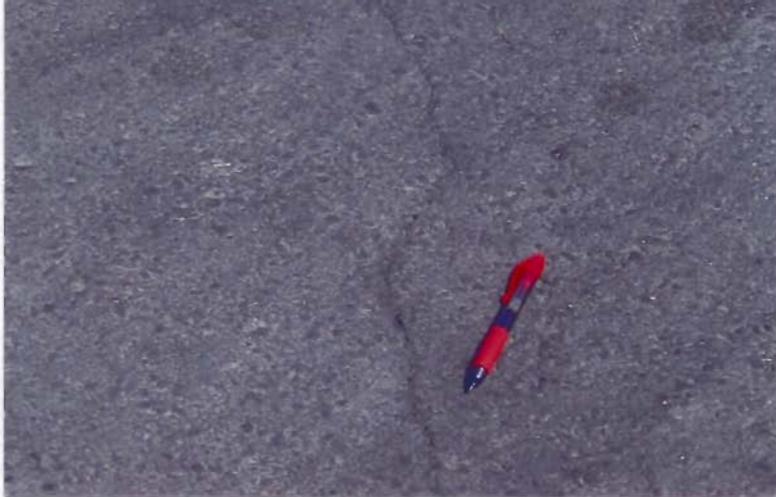
48

North West Side -
Cracks at A.C.
pavement

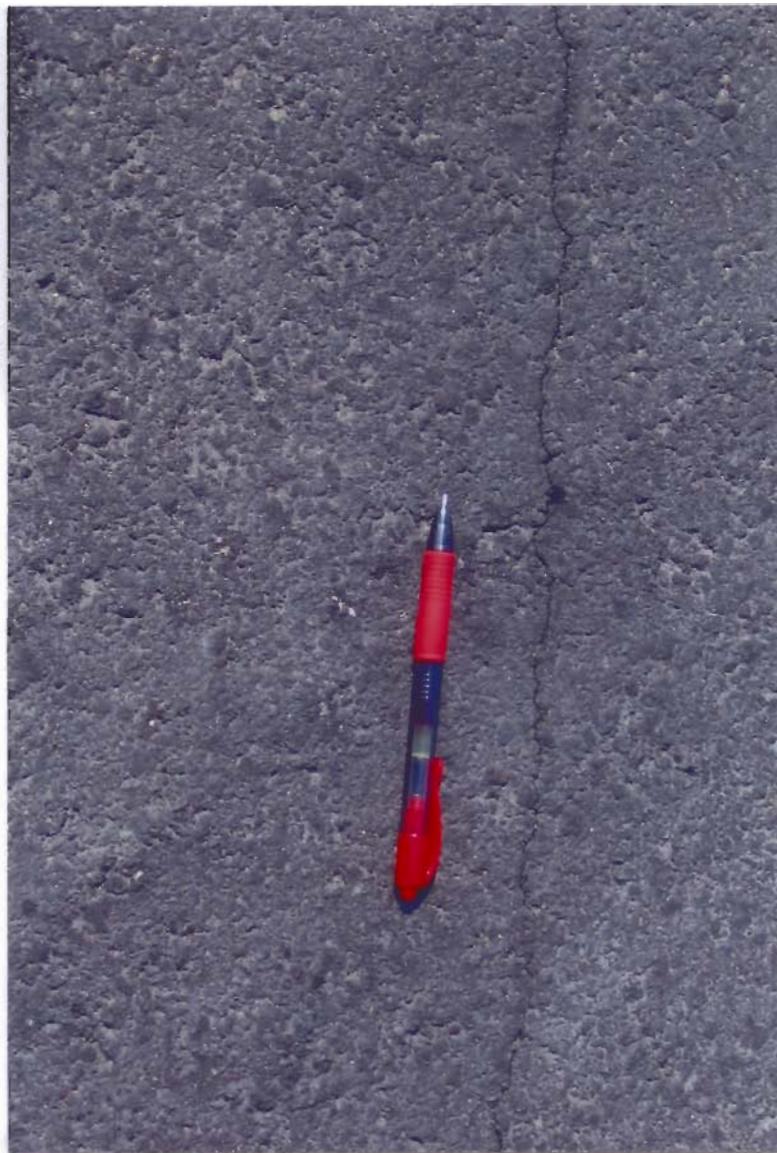
49

- E. Concrete Loading Dock - Concrete loading docks No. 2 and No. 4 have cracks on the slab and stairways. See photos.
- F. Boat Launching Ramp - Boat ramp has cracks on the slab. See photos.

West Side
Stair/Landing
cracks @
Loading Dock
No. 4

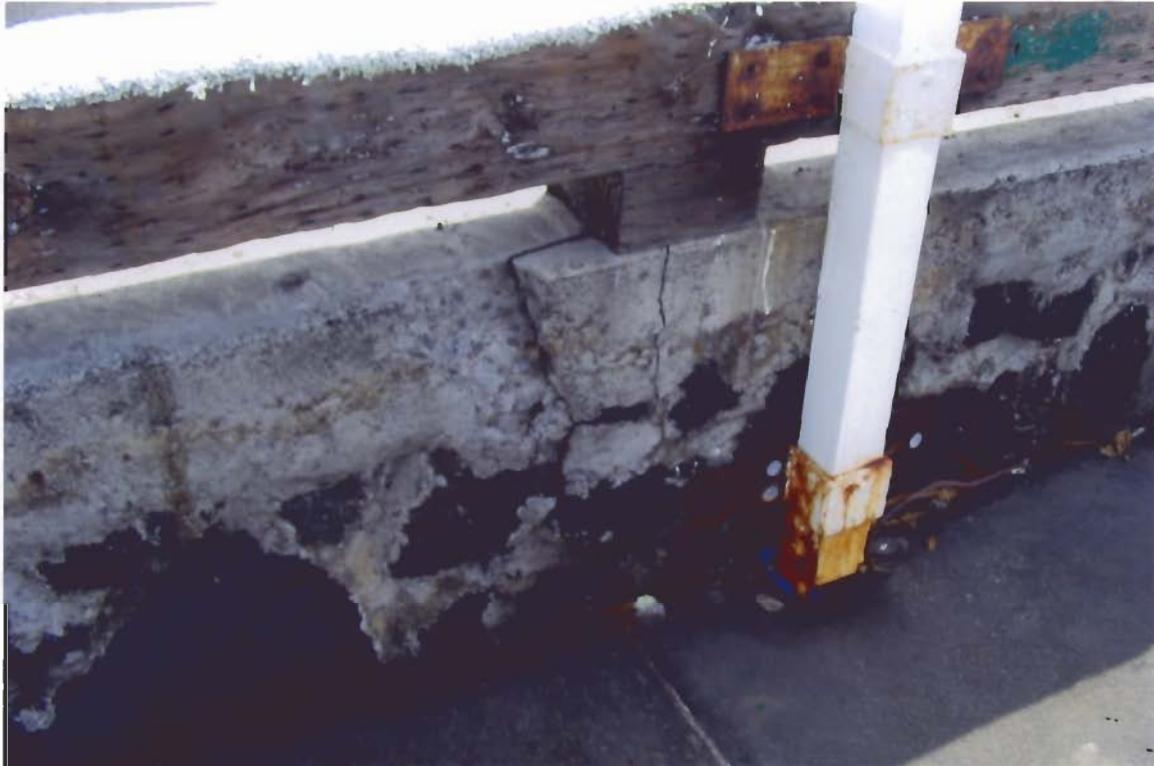
66

Crack CRM walls throughout
along Loading Dock No. 4

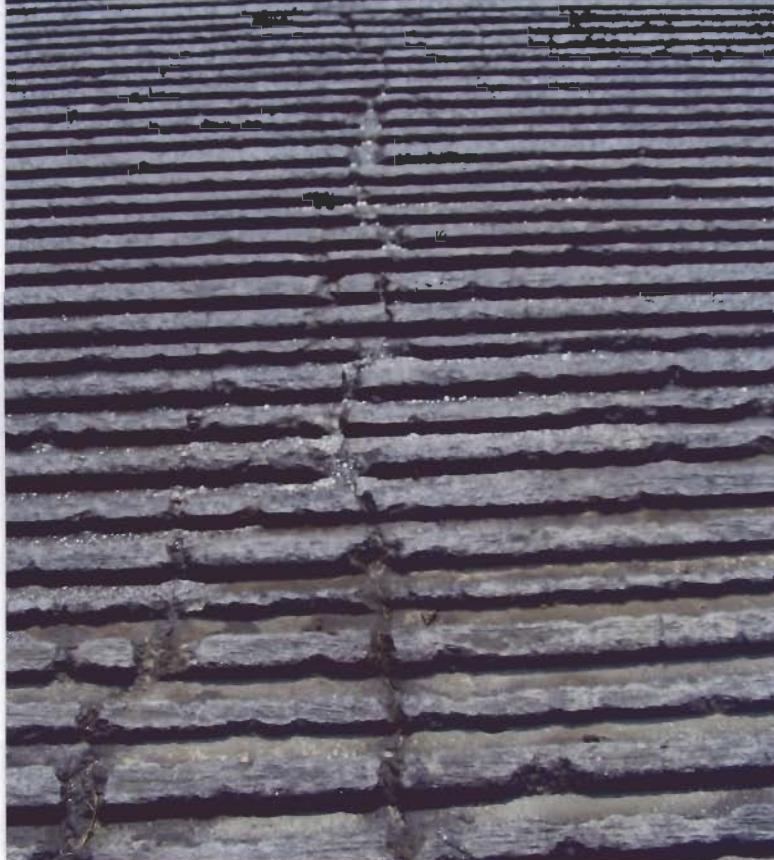
72

North West Side of Wharf -
Crack slabs at Boat Launching
Ramp

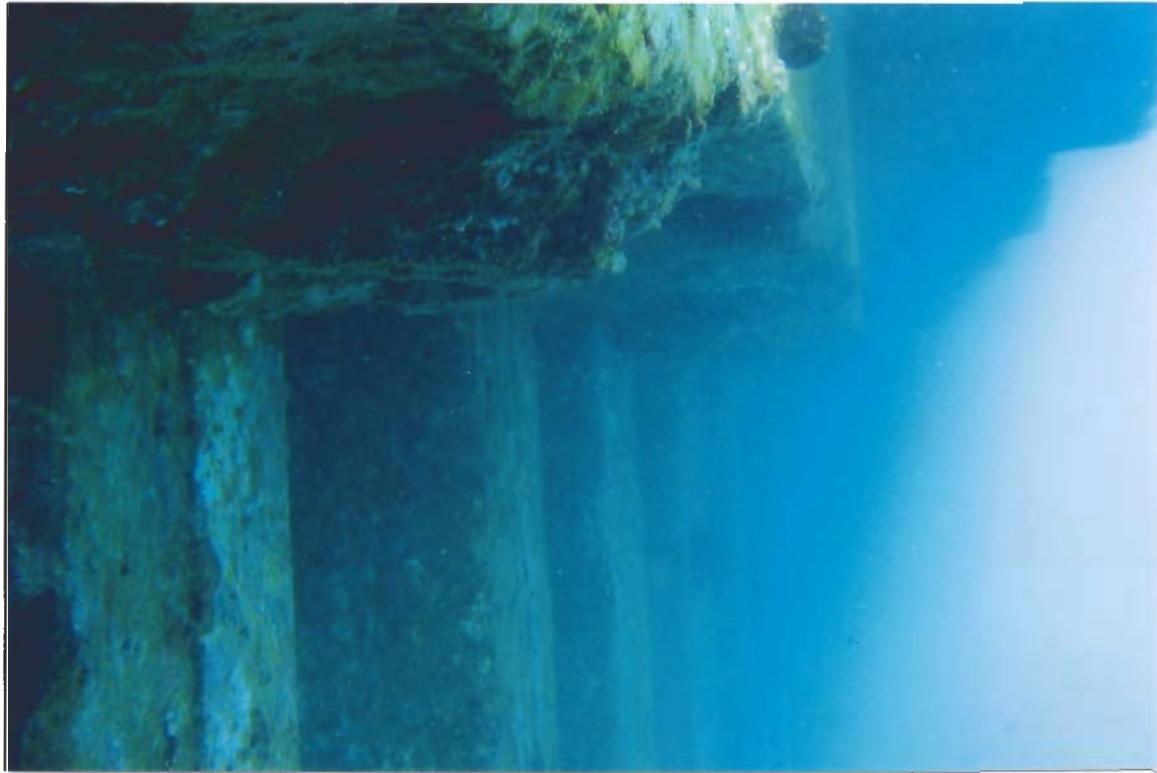
73

- A. Steel Sheet Pile for the Bulkhead - Steel sheet piles itself are in good condition. There are numerous areas of the steel sheet pile surface that the surface rust and marine growth had fallen off due to the bending and movement of the steel sheet pile from the earthquake.

Typical steel sheet pile bulkhead

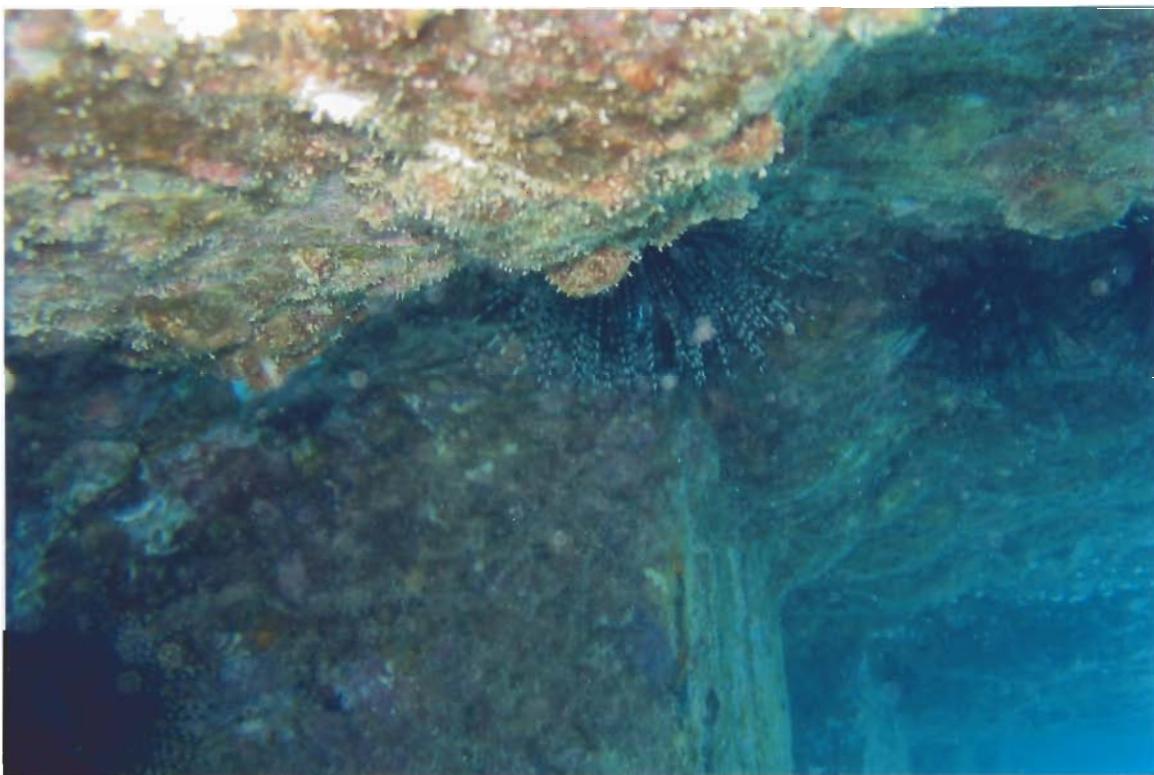
74

Sheet pile bulkhead - Concrete cap bottom
